REPORT
HAZARD MITIGATION OPPORTUNITIES
for the

CLIFF WALK
Newport, Rhode Island

Federal Emergency Management Agency

March 1992

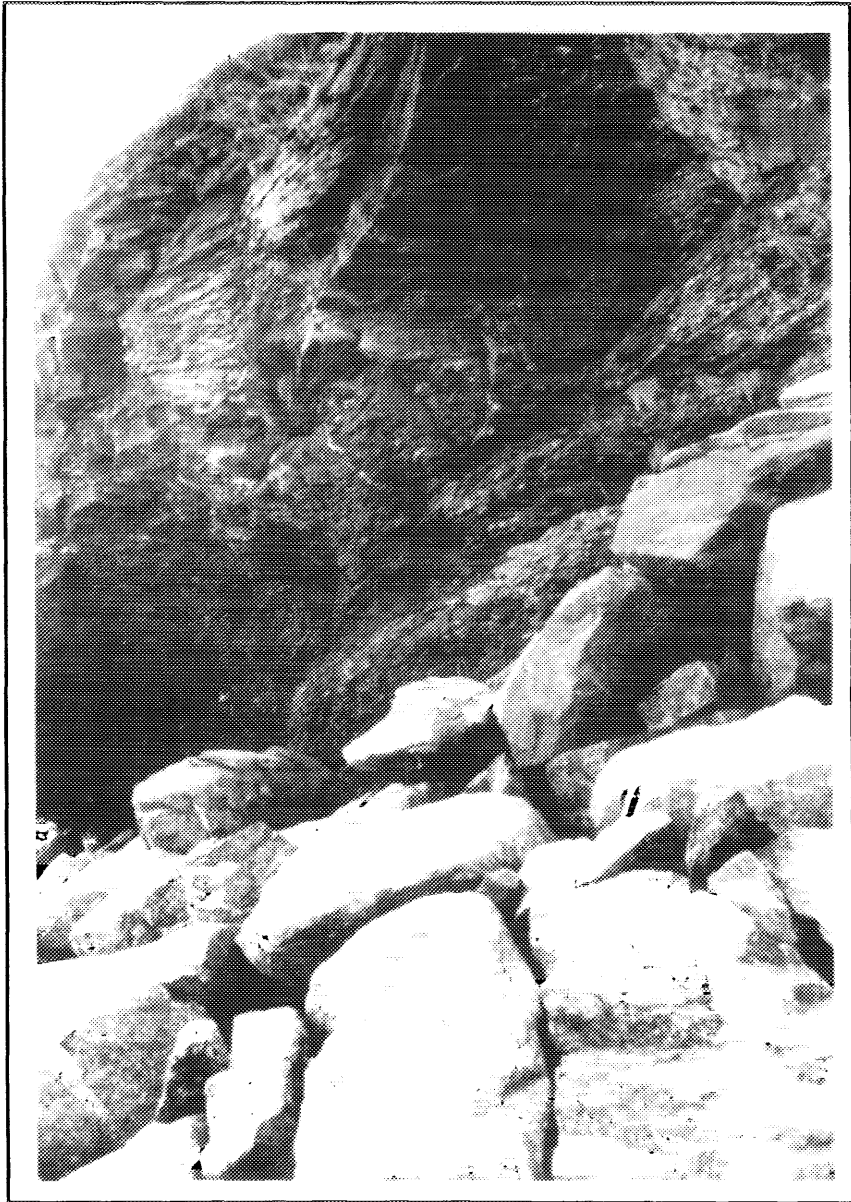
Site 10, View 1

This site, shown in Views #1 and #2 and Map 2⁸ on the following page, was identified in the 1988 ACOE Report as needing an extension of the existing riprap revetment, and construction of a new concrete wall and fence. Erosion damage to the cliff outcrop shown in View #1 has been continual over time, rather than specifically caused by the August 1991 hurricane. The Walk is located within several feet of the top of this cliff outcrop. It also appears that this outcrop may have a fault line which renders it particularly susceptible to future storm damage. It is likely that future storms could lead to the collapse of this outcrop, threatening the integrity and safety of the Cliff Walk in this area. Accordingly, among the damaged sites ineligible for Public Assistance, this site appears to be of higher priority for attention.

Since the September 1991 site visit, the state of Rhode Island has installed safety fencing along the seaward side of the Cliff Walk directly above this damaged area.

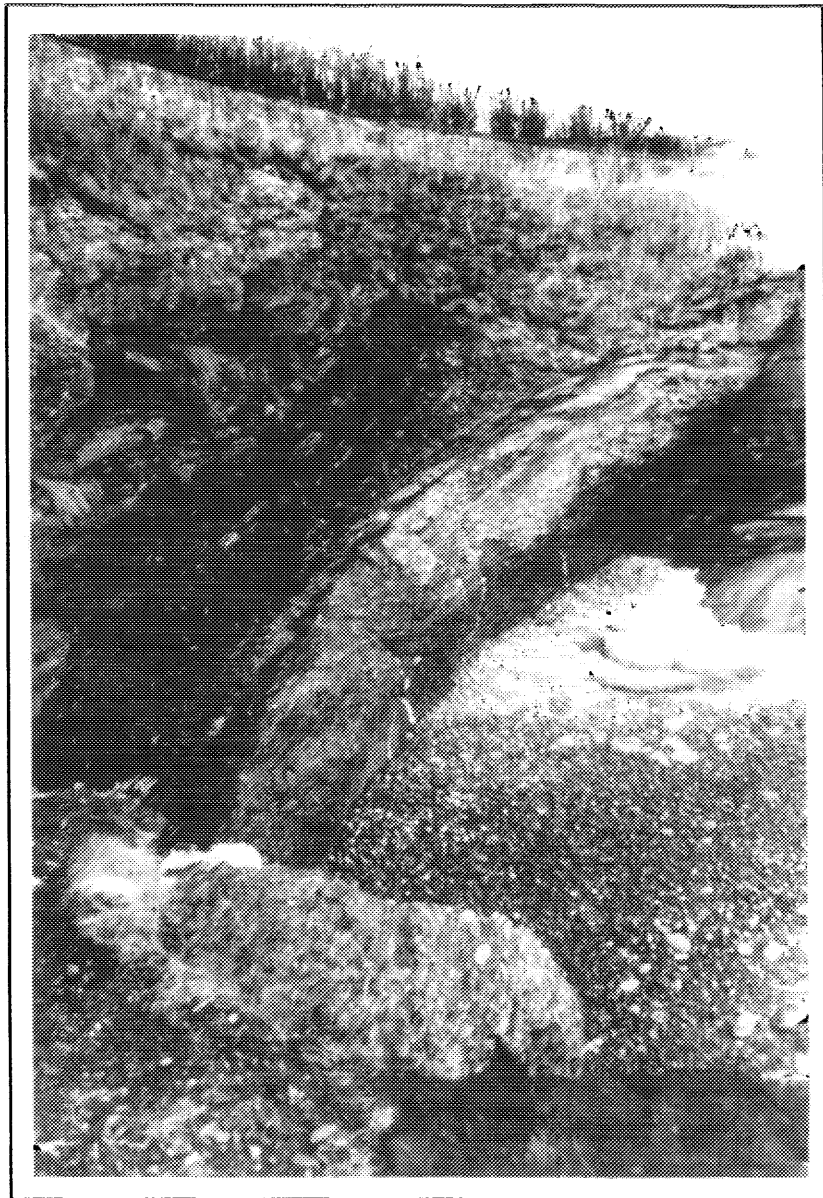
Site 7

Although comparison of the 1988 ACOE photos with September 1991 photos reveals no substantial amount of additional erosion, this site remains a critical area as identified by the ACOE since the cliff edge is within a few feet of the Walk. The ACOE report recommended installation of a 10 ft. high by 20 ft. long retaining wall to prevent future erosion damage. It also appears that planting of vegetation above such a retaining wall is needed to stabilize the soil below the Walk. Safety fencing has

been installed along the seaward side of the Walk above this area; hence there is no immediate threat to life safety at this point in time. Nevertheless, this site appears to remain as a higher priority for structural attention since the erosion is occurring within three feet of the path's edge.

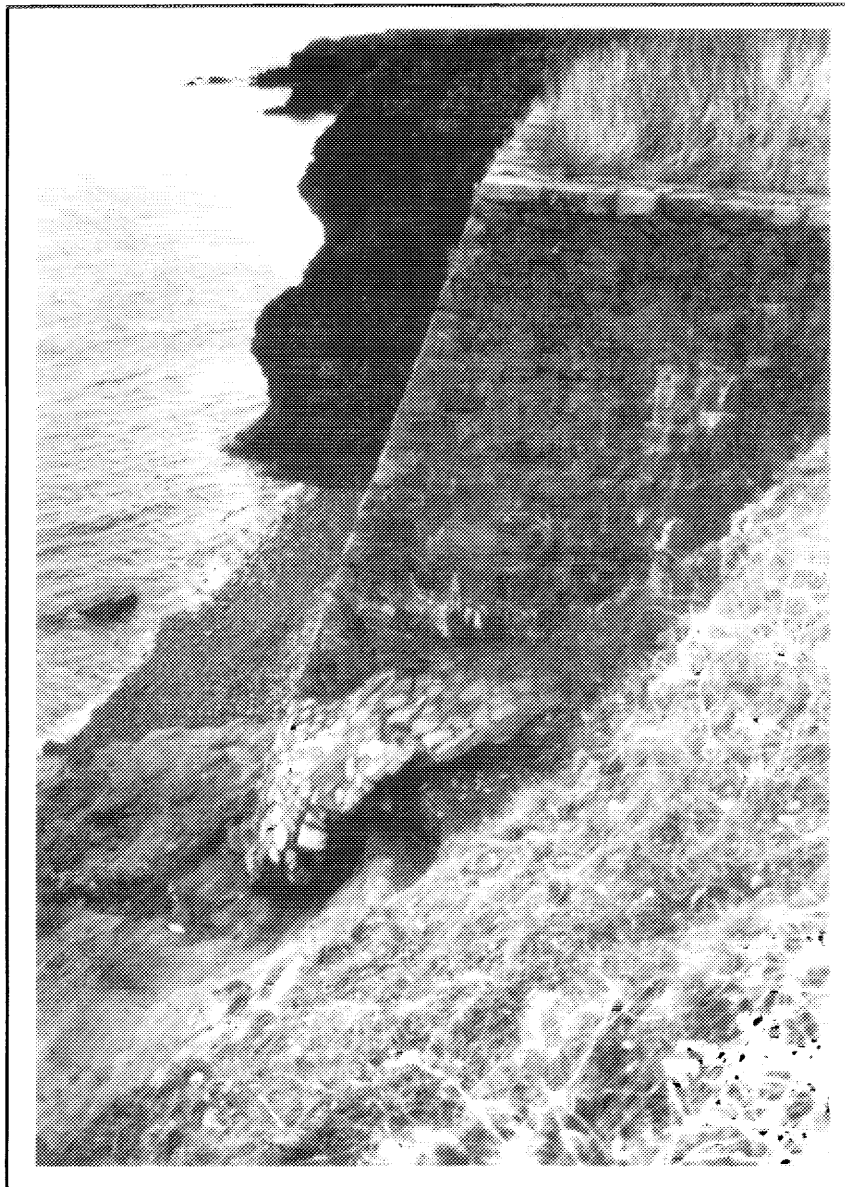
Site 11a

Both the north and south ends of the existing stone retaining wall which constitutes this site are eroding adjacent to the embankment. The Cliff Walk comes within about 4-6 feet of the eroding south end of this wall. The 1988 ACOE Report recommended that this wall be repointed and repaired.¹¹ As an existing structure, where continued deterioration could result in both damage to the Walk and future costly repair, this site should be given priority for attention. A recent report by the City of Newport recommends fencing, vegetation and drainage improvements for this site.¹²

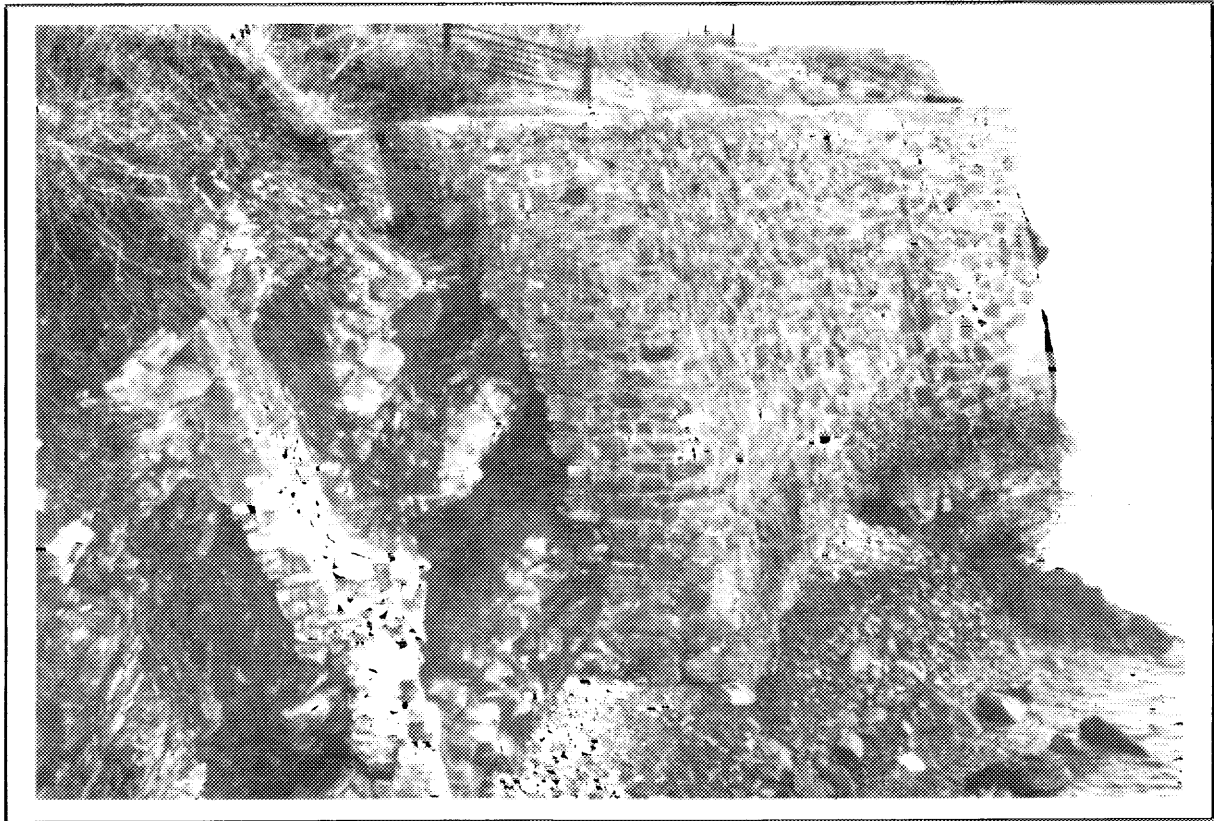
Site 12a

This site contains a stone masonry wall at the end of Shephard Avenue that was damaged prior to Hurricane Bob. Little damage has occurred to the wall since the 1988 ACOE Report. As in the case of Site #11a, this wall is a man-made structure which should be repaired and continually maintained. If left unattended, the potential damage and expense of repair is sure to increase. The City of Newport Report also recommends extending the proposed armor stone construction to further protect this area.¹³

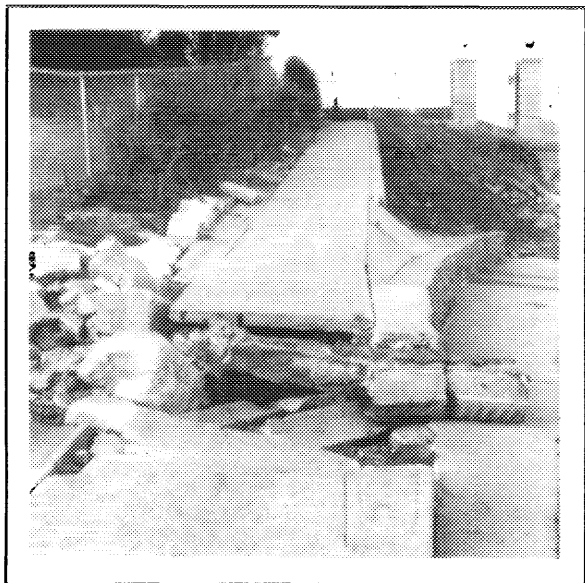
Site 18, View 1

One such example is Site 18. (See Views #1 and #2.) Here, failure to backfill the washed out areas behind the retaining wall allowed sea water and waves to undermine the ramp of the Cliff Walk and additional sections of the wall. In Site #30 (see photo below), unattended erosion damage to this concrete retaining wall has exposed the retaining wall footing.

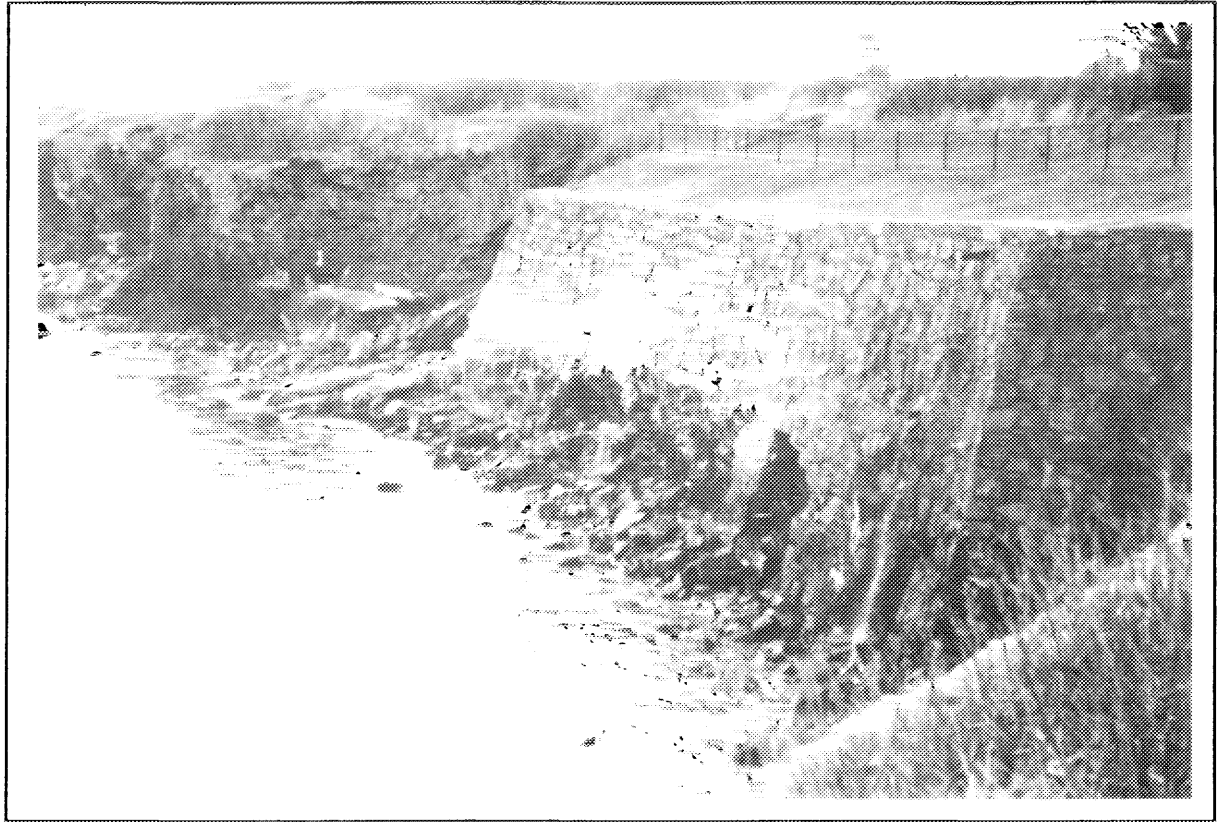
Site 12

In Site #12, wave action from Hurricane Bob caused structural loss in three large eroded cavities of a major retaining wall that, were it to fail, could undermine almost 75 feet of the Walk.
